An Assessment of the Quality of Hot Mix Asphaltic Concrete along Abuja-Lokoja Highway

Emmanuel E. NDUBUBA^{1*}, Abdulrahman. AHMED², Abdulganiyu SANUSI³

¹Department of Civil Engineering, University of Abuja, Nigeria

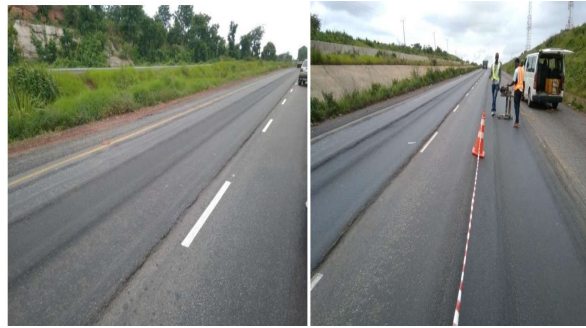
Figure 1: Rutted sections of Abuja-Lokoja highway

This paper investigated the causes of rutting as one of the major road failures experienced on most highways in Nigeria. The failures possess a wave-like shape and have resulted in several accidents and vehicular damages leading to loss of lives and properties (Ogundipe, 2008). This research further examined the causes of rutting failures on Nigerian roads after construction with a huge sum of money, thereby providing guilds for HMA design. As reported in this study, 170 kilometers Abuja-Lokoja dual carriageway highway has been one of the major roads that connect the Southern to Northern parts of Nigeria for decades. The reason for the selection of this road was that, at the final stage of rehabilitation and expansion of the road that has been in existence for the past 15 years, the road is already afflicted with rutting failures at several locations. Figure 1 shows the rutted sections of the concerned road.

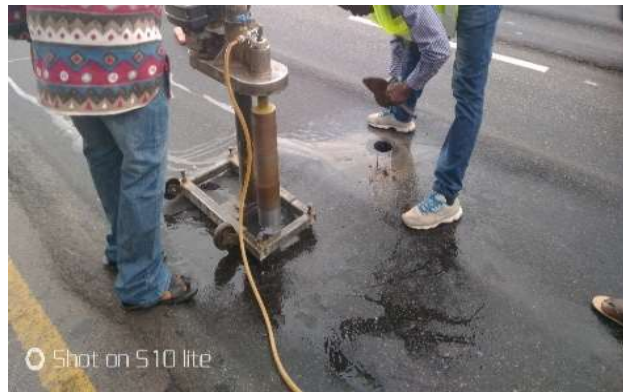
Figure 3: Asphaltic sample coring along Abuja-Lokoja road

In this study, a windscreen survey was carried out on the Abuja-Lokoja route. The road condition was examined at every 500m interval for rutting failure. The total road length considered was 14.5Km out of which three rutted and normal sections each were observed. Three samples each were cored out at the examined rutted and normal section for the laboratory analysis as shown in Figure 3 in accordance with (BS EN 12504, 2002; AASHTO T 24M/T 24-15, 2018). A total number of eighteen asphaltic sample were cored at the CH64+000 (8°36'50"N, 6°54'50"E), CH62+000 (8°37'35"N, 6°54'58"E) and CH53+000 (8°42'20"N, 6°56'18"E) for rutted sections and CH63+300 (8°37'35"N, 6°54'58"E), CH61+000 (8°38'27"N, 6°55'58"E) and CH49+950 (8°44'6"N, 6°57'16"E) for the normal sections respectively. The cored samples were subjected to testing for Marshall stability and flow, bitumen content, air voids, and particle size distribution for aggregate in accordance with British and ASTM Standards.

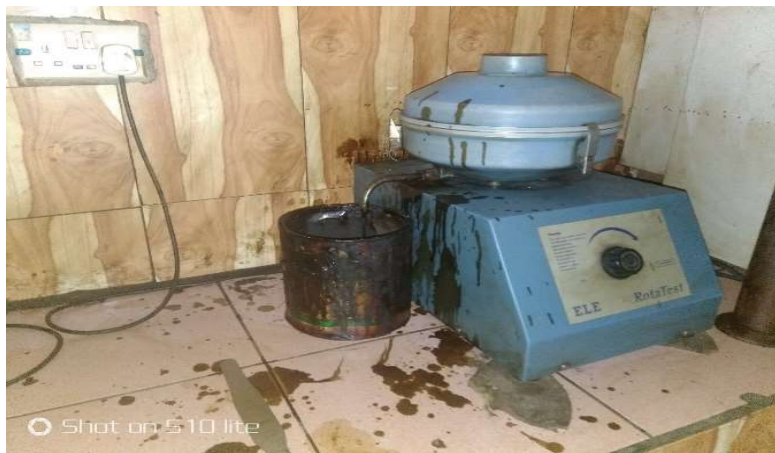
Figure 4: Bitumen Extraction from samples

After the sample preparation, the cored samples were subjected to Marshall stability and flow testing in accordance with the specification of (ASTM D6924-15, 2010; BS EN 12691-34, 2020). Also, bitumen was extracted from some cored samples to determine the percentage of air voids and bituminous content in the samples using British Standard BS EN 12697-8, (2019); BS EN 12697-39, (2018) respectively as shown in Figure 4. However, the residual aggregates from the extraction were washed and sieved for aggregate gradation testing in accordance with the method specified by (BS EN 12697-2, 2019a). Bailey's mathematical computation method was adopted to identify the deficiencies within the aggregates mixes and the determination of the aggregate fraction(s) that may require(s) adjustment.
